# Manhole Inspection Summary

Manhole # S17SS1003MH

Insp Date: **5/23/07 1:41 PM**

**Location** Address: **CYLBURN AVE**

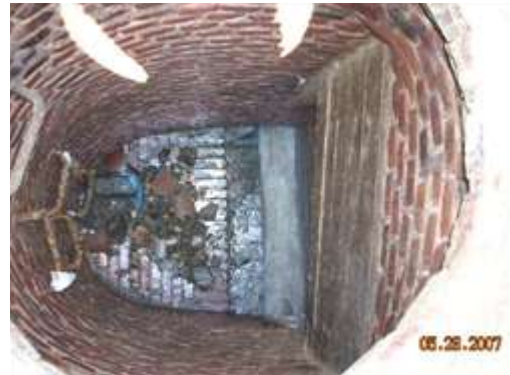
Top View

**Bench** ☒ Exists Material: **Brick** ☐ Parged ☒ **Debris** (not Condition related)

**Steps** Count: **5** Missing: **0** ☒ **Corroded**

**Surcharge** ☒ **Evidence Of Surcharge** Depth: **6** (ft.) ☐ Active Surcharge Present

Corroded steps. Evidence of surcharge - Bench debris.

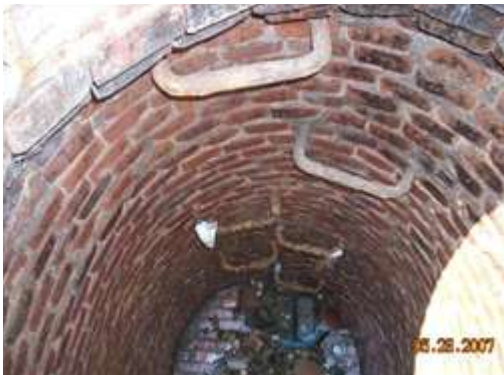
Defect

**Chimney / Frame Adjustment** ☒ Exists Material: **Brick** ☐ Parged Height: **6** (in.)

Condition: ☐ Sound ☐ Cracked ☐ Root Intrusion ☐ Loose Brick ☒ **Deteriorated**

Infiltration: ☐ None ☒ **Joint** ☐ Cracks ☐ Mortar ☐ Roots ☒ **Wall**

Adjustment deterioration and infiltration.

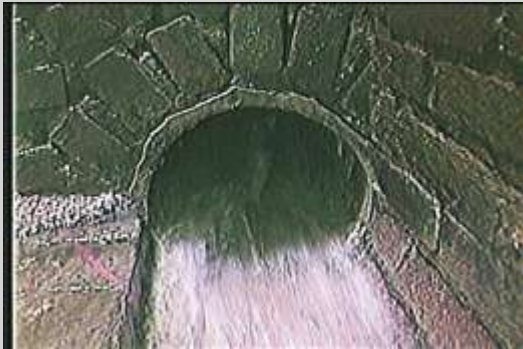
### 10 in. Circular Gravity Sewer Pipe Out @ 12 O'Clock

**Barrel** Material: **Brick** ☐ Parged

Condition: ☐ Sound ☐ Cracked ☐ Root Intrusion ☐ Loose Brick ☒ **Deteriorated**

Infiltration: ☐ None ☐ Joint ☐ Cracks ☒ **Mortar** ☐ Roots ☐ Wall

Condition: ☐ Sound ☐ Cracked ☐ Root Intrusion ☒ **Deteriorated** ☐ Leaks ☐ Debris

Barrel deterioration and infiltration. Channel deterioration.

Infiltration: **None** Pipe Seal Cond: **Cracked**

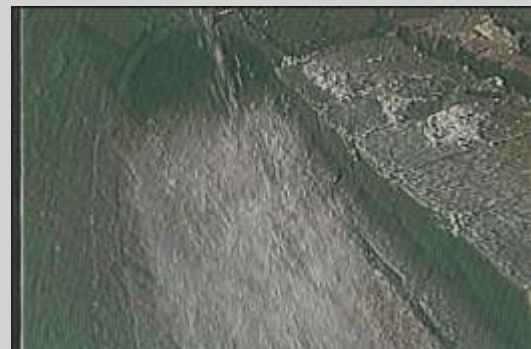
### Drop In @ 6 O'Clock

Barrel deterioration and infiltration. Channel deterioration.

Drop Condition: **Partly Clogged**
